# Manhole Inspection Summary

Manhole # S11II\_012MH

Insp Date: **10/9/07 10:21 AM**

**Location** Address: **REAR 3108 NORTH AVE**

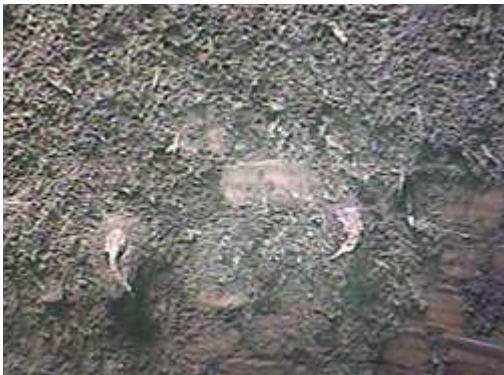
Defect 1

**Steps** Count: **10** Missing: **2** ☒ **Corroded**

MISSING/ CORRODED RUNG

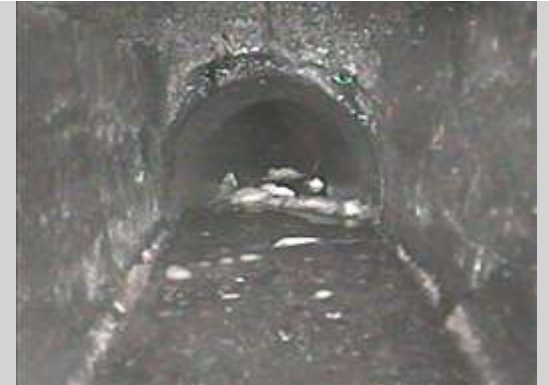
12 O'Clock Outflow

8 in. Circular Gravity Sewer  
Pipe Out @ 12 O'Clock

Pipe Height: (in.) Direct  
Pipe Material: **Clay** ☐ Pipe Lined  
Invert Depth: **13.64** (ft.) Flow Characteristics: **Slow**  
Deposits: ☐ None ☐ Mud ☐ Sludge ☒ **Debris** ☐ Grease  
Silt Depth: **1** (in.) Deposits Extent: **Light**  
Infiltration: **None** Pipe Seal Cond: **Sound**

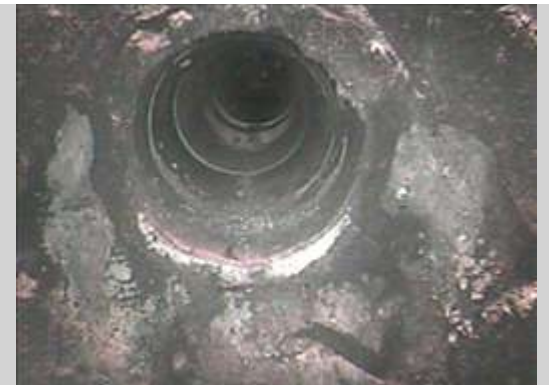
6 O'Clock Inflow

8 in. Circular Gravity Sewer  
Pipe In @ 6 O'Clock

Pipe Height: (in.) Direct  
Pipe Material: **Clay** ☐ Pipe Lined  
Invert Depth: **7.03** (ft.) Flow Characteristics: **Slow**  
Deposits: ☒ **None** ☐ Mud ☐ Sludge ☐ Debris ☐ Grease  
Silt Depth: (in.) Deposits Extent:  
Infiltration: **None** Pipe Seal Cond: **Sound**

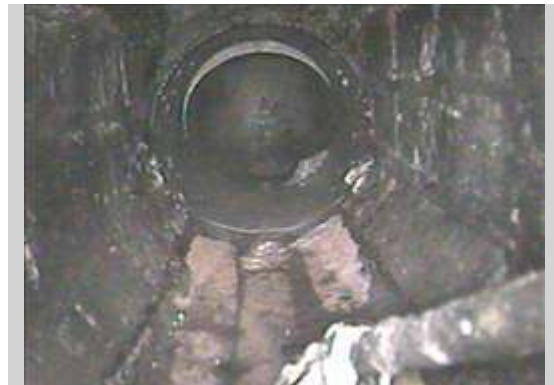
Drop In @ 6 O'Clock

Drop: **Outside Direct**  
Angled: Reading: (ft.)  
Inv Depth: **13.69** (ft.)

Drop Condition: **Open**
